Cherokee Hints and Tips 2000

A Piper Cherokee Source-book

Introduction to Cherokee Hints & Tips 2000

The Cherokee Hints & Tips 2000 manual incorporates information which originally appeared in the Piper Owner Magazine and other publications. It contains the best of the articles pertaining to operation and maintenance of Piper Cherokee aircraft.

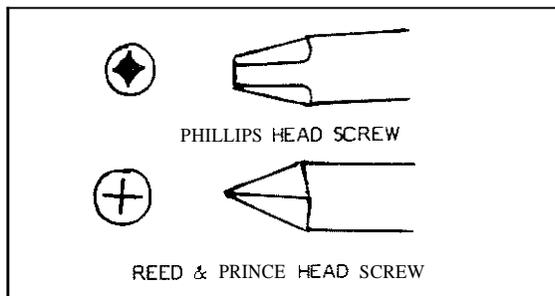
You will need some Phillips screwdrivers, too. Not all cross-slotted screwdrivers, however, are really Phillips, Phillips screws have a rounded slot while a true pointed head is known as a Reed & Prince screw.

These types of screwdrivers are not interchangeable. Keep both kinds of screwdrivers on hand and be careful to examine any cross-slotted screws carefully before choosing a screwdriver.

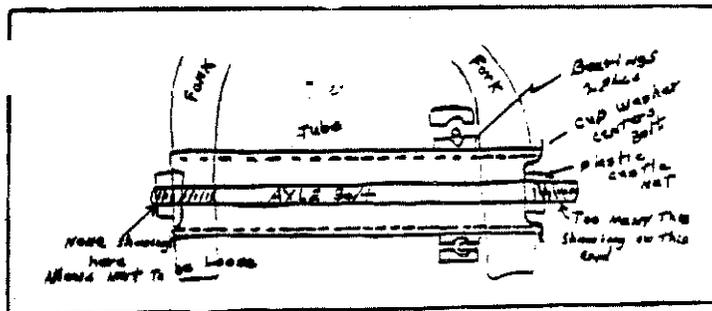
The front axle holds a tube in place that acts as a bearing support shaft. The axle bolt is about one-half inch in diameter. It is held in place with two castle plastic nuts. If these nuts are tightened evenly, then the plastic castle nut keeps them from vibrating loose.

However, if one nut is tight and the other is just started, then the plastic in the castle nut does not come into play. Thus, the front axle is held in place with a nut which is just hand tight.

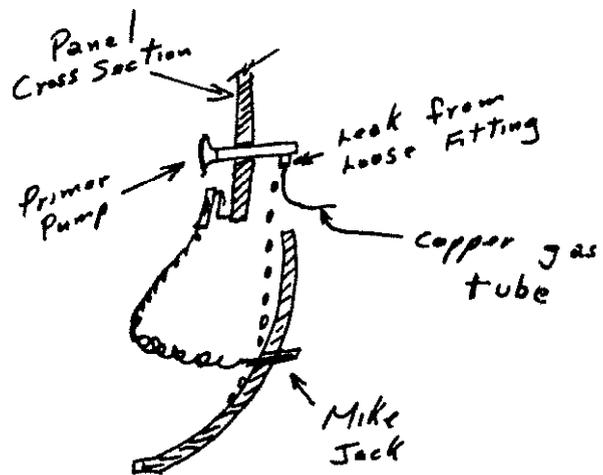
Recently I solved a raw gas smell in the cabin that had been annoying me for a year. It was caused by a loose fitting where the copper gas tube connects to the primer

pump on the inside of the panel.

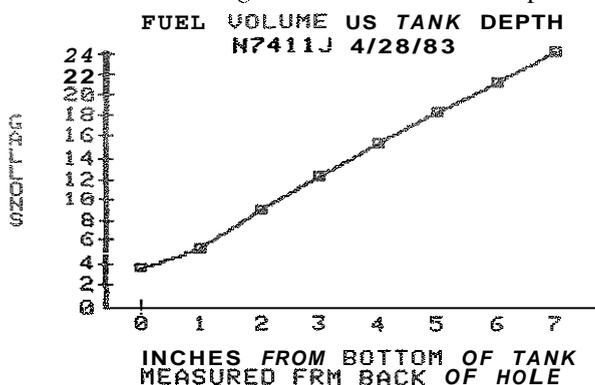
I developed the graph below by draining my fuel tank and measuring at each inch as it came up. It is a good

check on the fuel gauge. I thought you might like to use it.

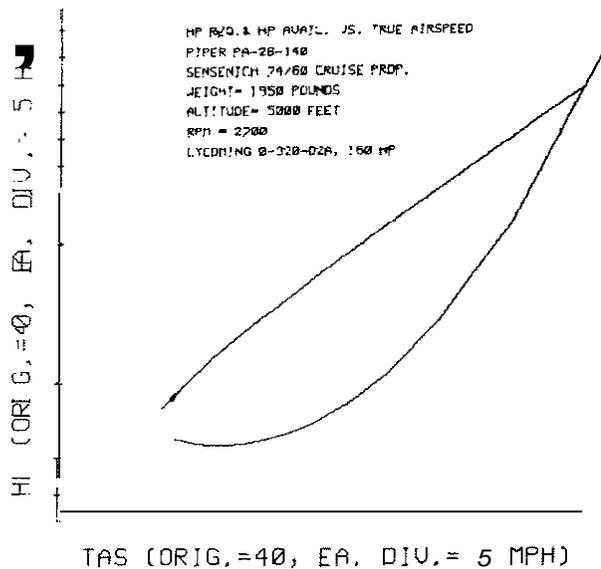
Note the horizontal axis starts at 40 mph and each mark is an additional five mph. These are true airspeeds at the selected altitude.

The vertical axis starts at 40 hp with a mark at each additional five horsepower. The lower curve is the calculated thrust horsepower required for the early PA-28 design with the old-style wheel fairings and, again, at 1,950 pounds flying weight and 5,000 feet of altitude.

The upper curve is the thrust horsepower from a Lycoming 160 engine with a 74"/60" propeller.

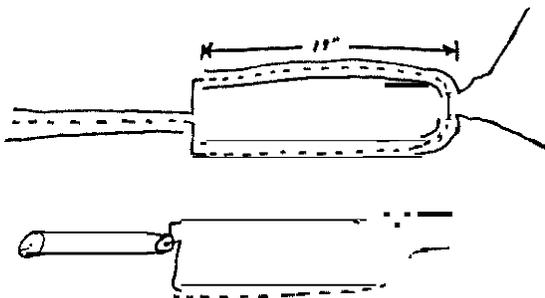
The "V" antenna on the tail of the plane is not simply connected to the cable to the nav portion of the radio. In order that the radio look to all points of the compass correctly we must have a special system of wiring this antenna using a Balun.

This Balun can be made entirely from RG58/U. It is often a source of trouble in older planes due to corrosion and should be inspected and replaced if it looks defective.

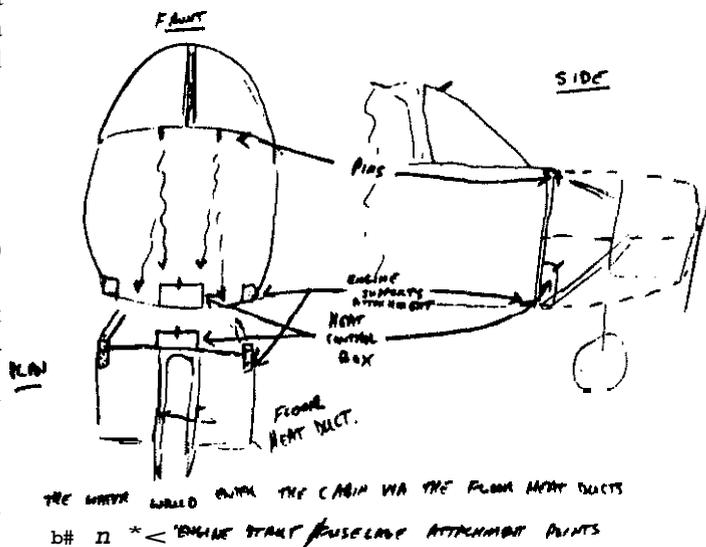
The water was trickling down the gap between the fuselage and the upper engine cowling into the upper cowling rear pin holes and down the firewall to the heat control box and along the bottom lip of the firewall to the engine support attachment points (left and right) penetrating the bottom of the firewall.

Thus the water entered the cabin at the heat control box and the support attachment points.

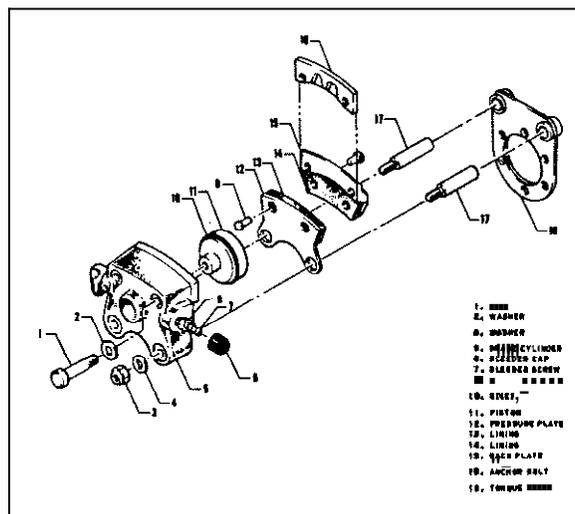
Wheel Brake Assembly

Piper uses the ever popular Cleveland brake system - popular because it is so basically simple. Cleveland brakes, for example, can be relined without jacking the plane or removing the wheel.

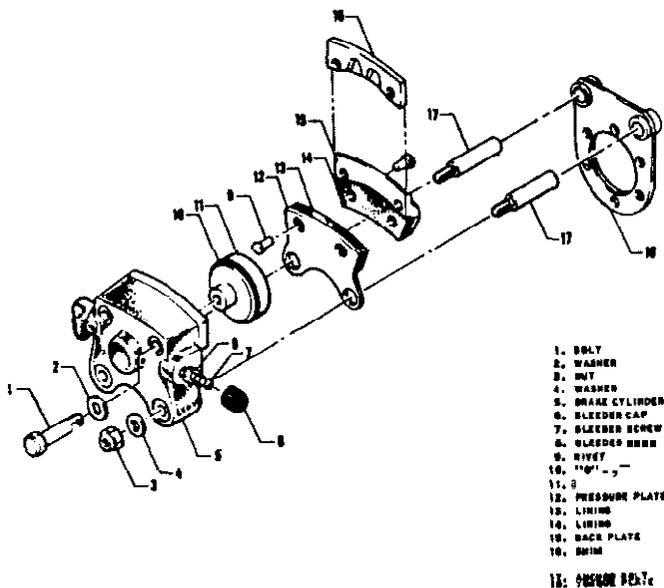
First of all, be aware that although most Cherokees come with single-piston brake assemblies, dual-piston planes are not uncommon. The main difference is simply

the number of hydraulic pistons used to compress the assembly.

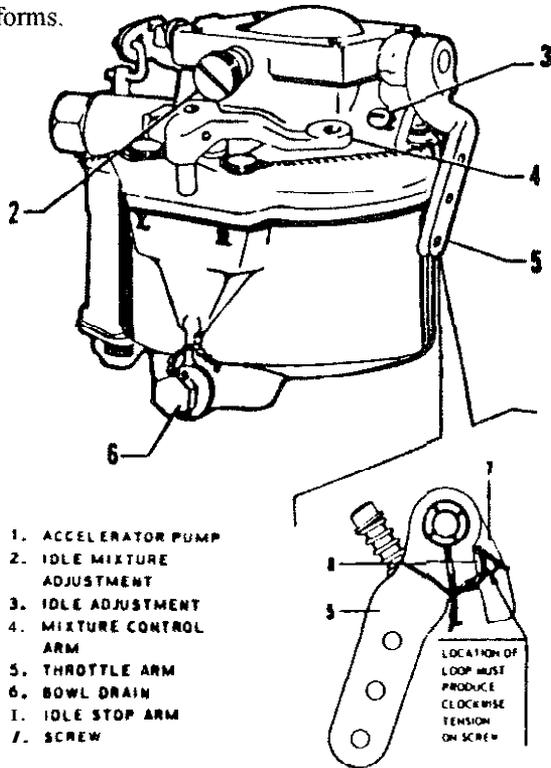
TIGHTEN THROTTLE ARM SCREW (8) TO 20 - 28 IN. LBS. TORQUE

As we see in the schematic diagram, fuel enters the carburetor past the fuel screen into the float chamber. The float chamber is designed to supply a constant level of gasoline to the main discharge nozzle.

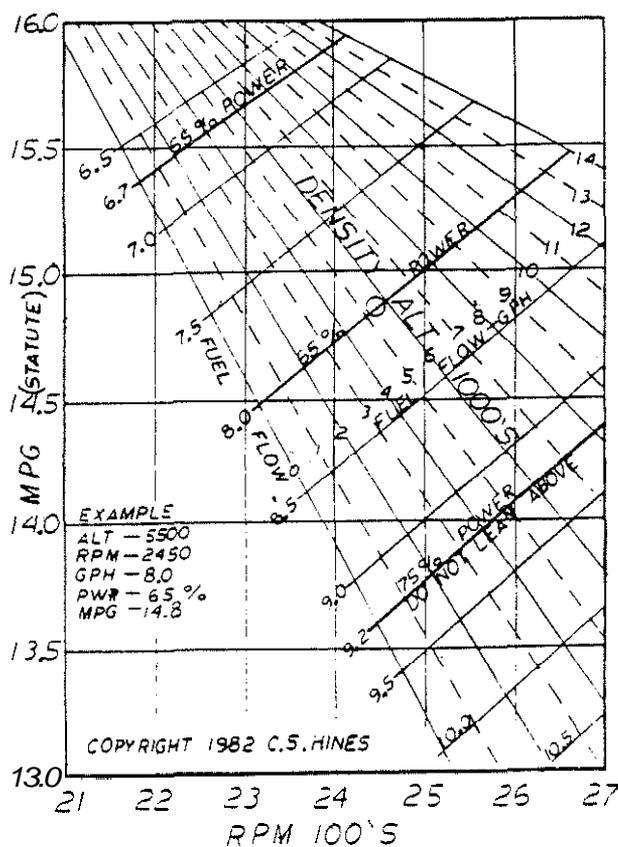
Using this chart is very easy (see the example). It is used most often to find the rpm needed to give the desired power setting (fuel flow) after reaching cruise altitude.

Step-by-step: 1) Read density altitude from altitude conversion chart, after reaching your cruise altitude; 2) Find density altitude line on chart; 3) Locate its intersection with chosen power setting (fuel flow); 4) Read down to find rpm.

In the example given the density altitude is 5,500 feet, the power setting is 65 percent (8.0 gph) which gives the rpm to use as 2,450. That is all there is to it.

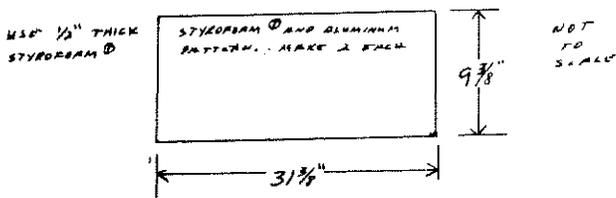
FIG. 1 - REAR FLOOR PANELS, LEFT AND RIGHT SIDE

FOR PA28-140-4 AS INSTALLED IN N7500R

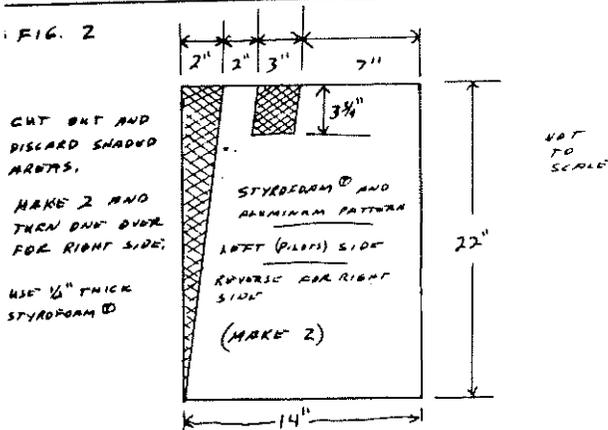
FIG. 2

COMPOSITE DETAILS:

USE BONDING AGENT SUCH AS PANEL ADHESIVE, BETWEEN THE CARPET, ALUMINUM AND STYROFOAM. ALUMINUM SHOULD BE THIN, ABOUT 1/32". THE STYROFOAM SHOULD BE TREATED WITH A FIRE RETARDANT SPRAY. CARPET SHOULD BE APPROVED FOR AIRCRAFT USE.

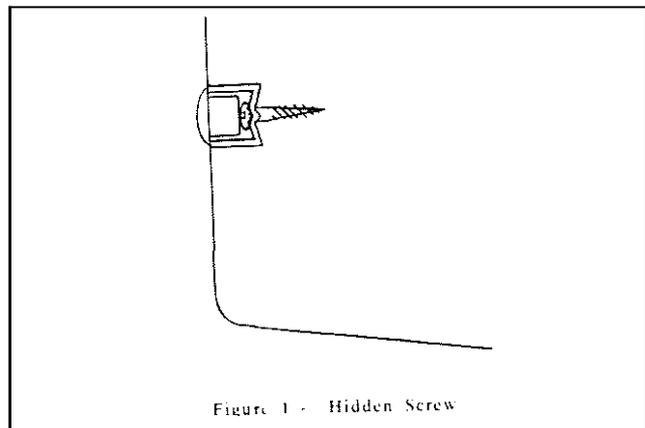
Note that the panels around the side windows have screws hidden under little plastic covers. You must carefully pry the covers off and remove the screws inside. For a cross section of the arrangement, see Figure 1. By the way, I did not have to replace any of these covers, and I don't know where to find new ones if you lose or break them.

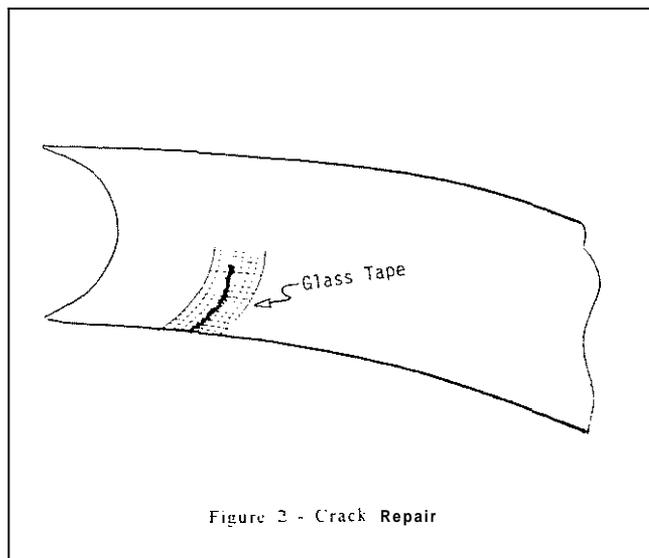
Figure 2 - Crack Repair

At this point any cracks should be repaired. You should cut a piece of glass tape to cover the crack on the unexposed side of the plastic panel part. Then prepare a two part epoxy mixture and coat the tape in place. Make sure that the epoxy does not run out through the crack or around the edge of the panel to the exposed side (see Figure 2). Allow to harden overnight.

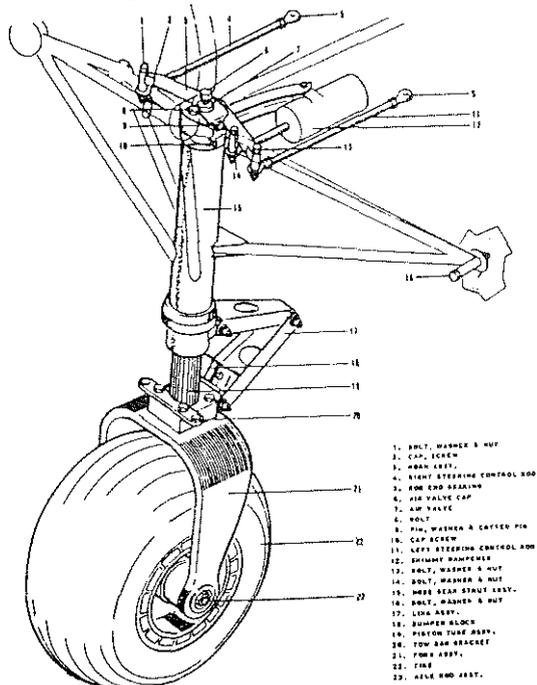
Close investigations of the nose gear revealed that the nose gear fork assembly (item 21 in the diagram) had been installed backwards on the piston tube assembly (item 19 in the diagram)!

The correct installation on the 140 is when the center line of the nose wheel axle is slightly forward of the center line of the piston tube (note the diagram). That correct installation of the fork causes the caster effect to attempt to hold the nose wheel straight ahead during landing roll-out.

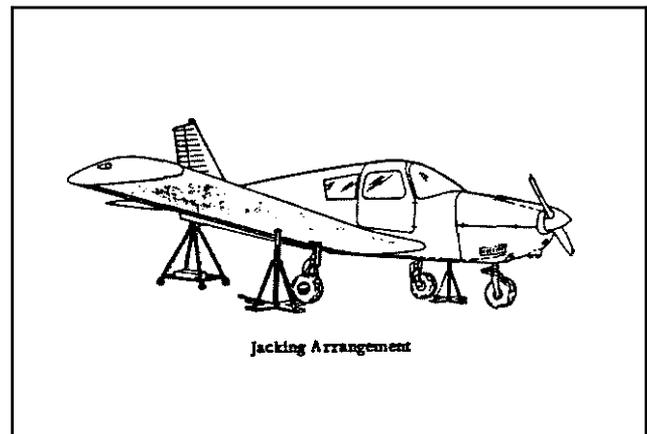
If the wear is off side, that is the outside or inside is wearing more than the other side of the tire, you may want to periodically dismount the tires and turn them around on the rims to balance the wear.

Such a condition may indicate that the gear is out of alignment and should be aligned by your mechanic. If the condition exists on the nose wheel, it may indicate a dragging brake or improper towing techniques. Once again,

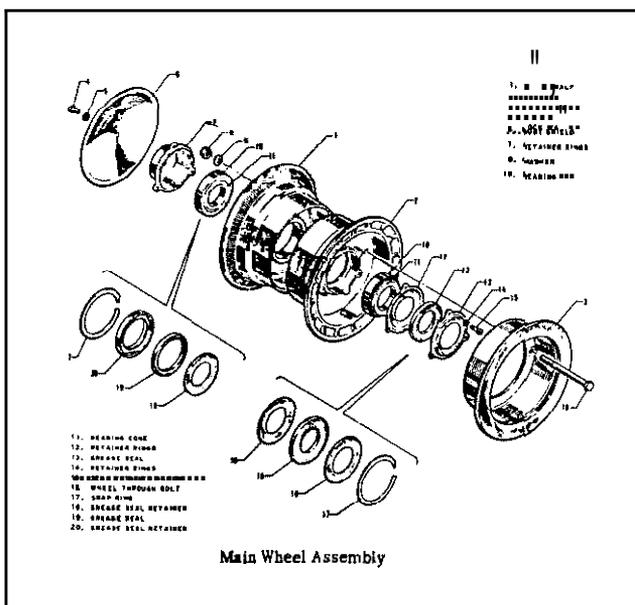
If you are working on the nose gear rather than a main gear, the procedure differs slightly. The nose gear fairing must be loosened and it will then slide up the fork straight up to permit access to the wheel.

Remove the nut and washer from one end of the axle rod and slide out the rod and the axle plugs. Then, lightly tap the axle tube out from the center of the wheel assembly by use of an object of near equal diameter, being careful not to damage the axle tube.

Then, remove the spacer tubes and the wheel assembly and finally, slide down the wheel fairing and remove it by turning it sideways.

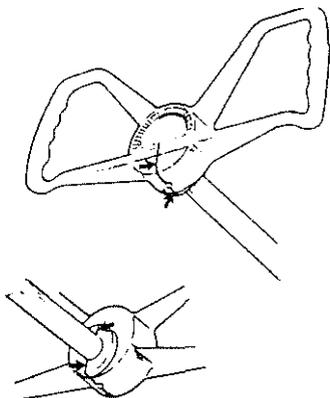
Installing Newer Control Wheels

Members ask from time to time about installing newer-style control wheels in older model Cherokees. One

member recently called in to remind everyone that the procedure is specified in Service Letter 527D.

Cherokees built before 1978 were subject to a repetitive requirement to inspect the control wheels for cracks each 100 hours. Cracks were found on a number of control wheels where they connected with the shaft.

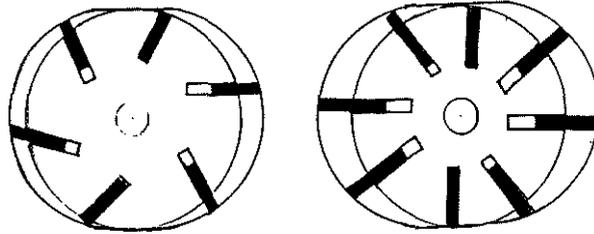
Let's take a look at the construction of a dry vacuum pump. Actually, there are two brands of pump which operate pretty much the same, but differ in construction details.

Airborne Pump

Sigmatek Pump

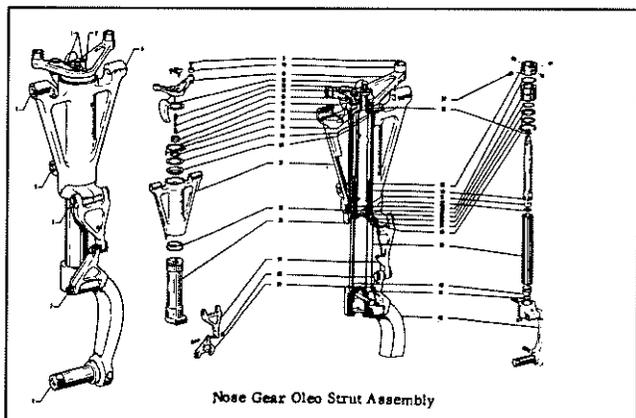
First, determine whether the strut is low on air or oil. The test is simple. Using a wing tip, rock the plane a few times on the gear. If the plane bobs up and down in short strokes and stops after just one or two bobs, you need to add air. If it travels in longer strokes and continues to bob after you stop rocking the wing, you need to add oil.

To service a strut the wheel needs to be off the ground. Jack up the wing or apply weight to the tail through the tail skid to raise the nosewheel. Be sure to chock the other wheels to prevent the plane from moving.

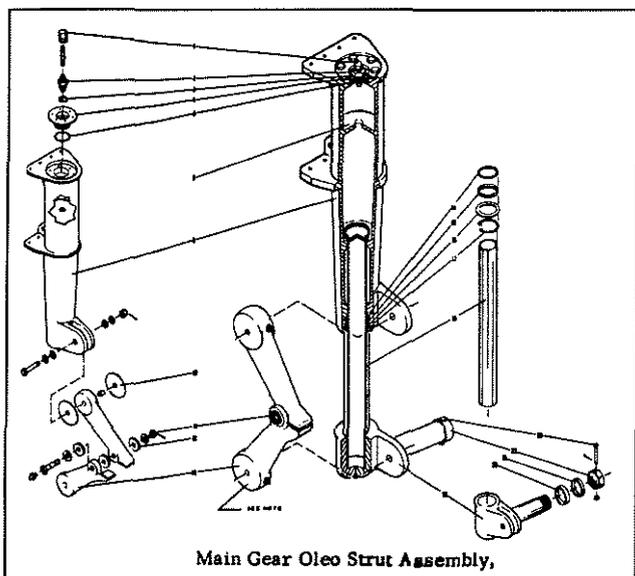
Main Gear Oleo Strut Assembly,

With the airplane removed from jacks and the wheel sitting on the ground, air from the strut pump is added via the filler valve until the extension is correct. Jiggle the wings to be sure the strut has settled down. Piper specifies tube exposure of 3.25 inches for the nose gear and 4.5 inches for the main gear of a PA-28 with fixed gear, and 2.75 inches for the nose and 2.0 inches for the main gear of a PA-28R.

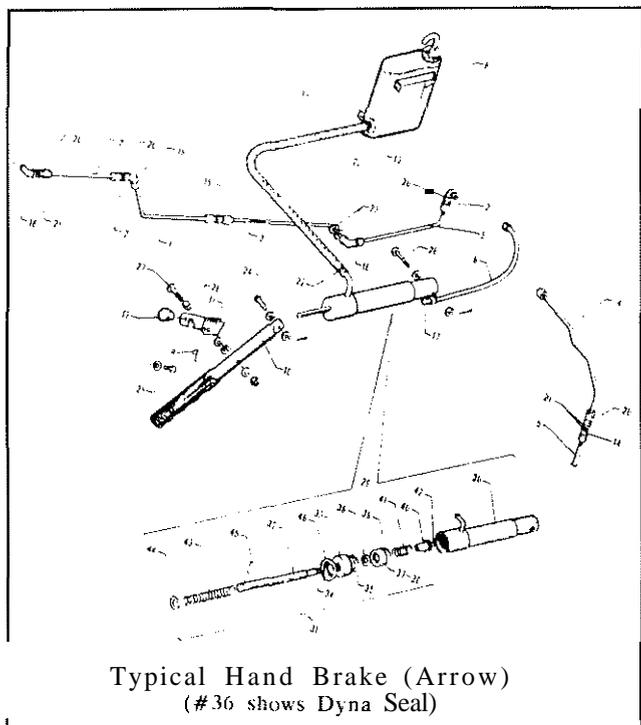
Bleeding the Brakes

We have seen that bleeding Piper brakes cannot solve all problems with spongy brakes. However, whenever

air is allowed to enter the system, such as when brake cylinders are repaired or replaced, the system is going to have to be bled.

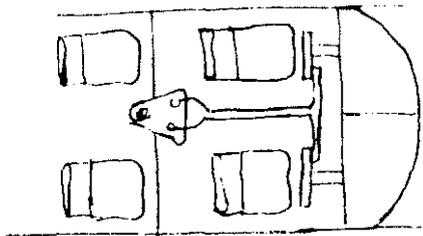
- 1) Mount "fitting X" into the plywood cover between the rear seats.
- 2) Place the tow bar on the triangular piece of metal.
- 3) Fasten the triangular metal to the plywood "fitting X" with the wing nut.
- 4) Secure the yoke with the flat belt.
- 5) Lay the tow bar on the flat belt with the handle of the tow bar forward of the control wheels. Secure with the bungee cord.

This neutralizes the controls and has worked well for me. You can protect the yoke by placing bicycle handle bar grips on the tow bar handle.

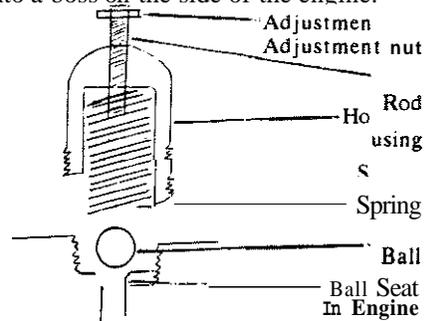
The top hat type has a housing that looks like a top hat screwed into a boss on the side of the engine.

The valve can be adjusted by adding up to a maximum of nine STD-425 washers under the cap, on top of the spring, to raise the pressure. Your problem is that due to the viscosity of the mineral oil and the flow capacity of an overhauled oil pump, the relief valve ball is held off its seat very high. The result is a lot of bypassed oil and pressure.

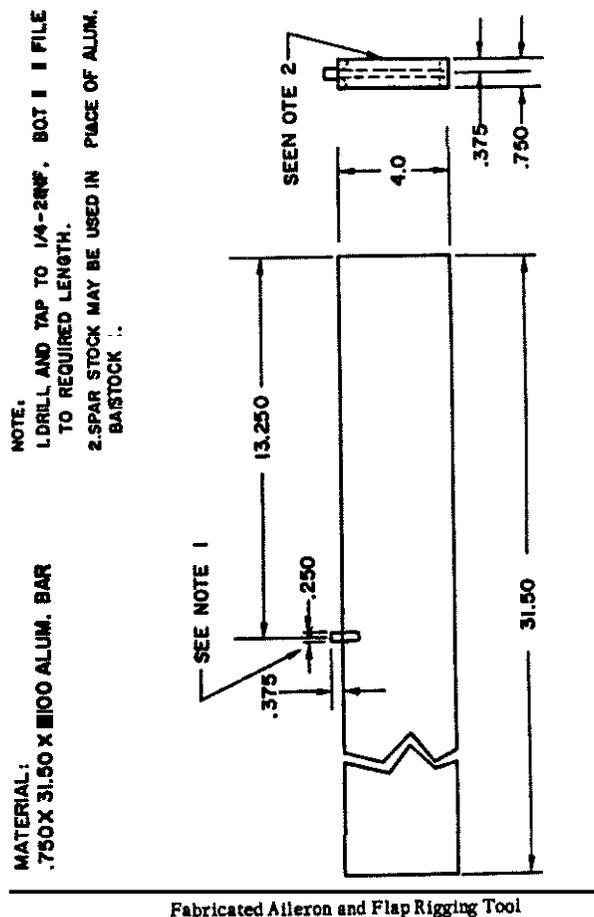
To rig both the ailerons and flaps you will need to fabricate a special tool. The instructions are given in the manual (see the accompanying diagram).

To check the neutral flap position, the rigging tool is placed at the bottom of the wing and flap as close as possible to the outboard end of the flap (be careful not to touch any of the rivets.)

The tool is positioned parallel with the wing ribs and with the back end of the tool flush with the trailing

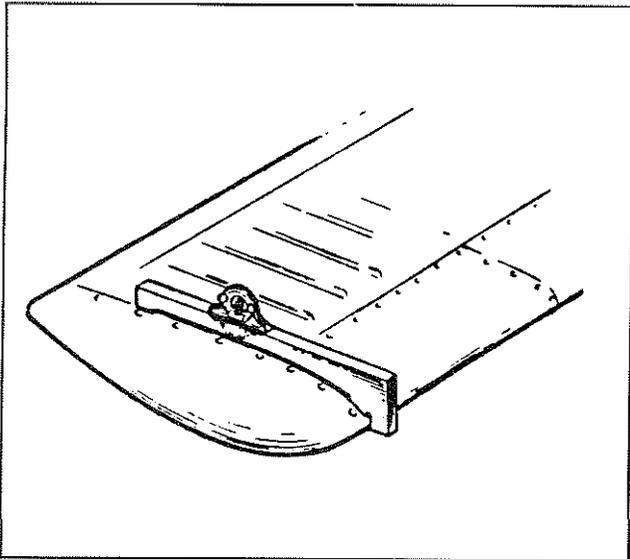
To determine proper travel it is necessary to make a stabilator rigging tool. This tool is then placed on the

upper side of the stabilator at the outer spar.

A bubble protractor is then mounted on the tool and the movement of the stabilator from level position is checked. (Note: a bubble protractor is an instrument which is a cross between a simple protractor and a carpenter's level.)

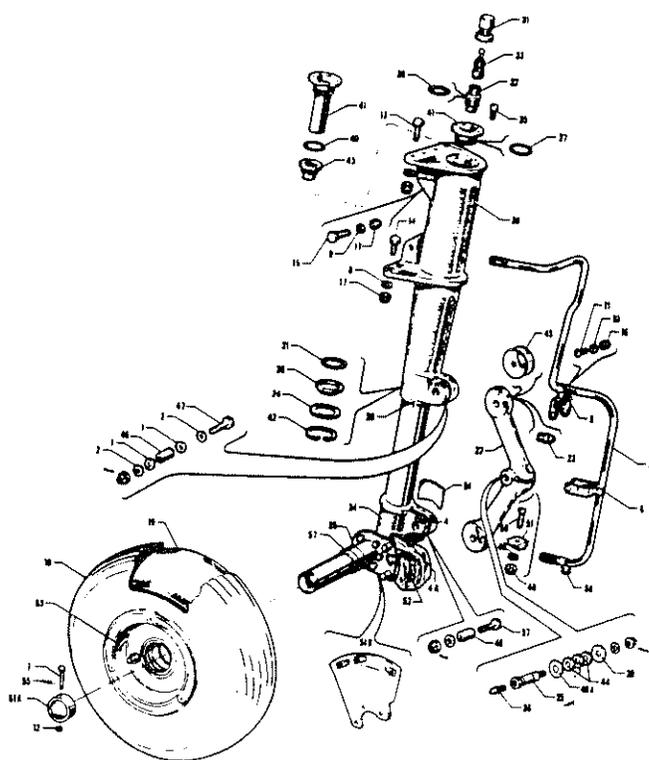
Main Gear Installation (140)

2. Set a square against the straightedge and check to see if its outstanding leg bears on the front and rear side of the brake disc. (It may be necessary to remove the brake assembly to gain clear access to the disc. If it touches both forward and rear flange, the landing gear is correctly aligned. The toe-in for the main landing gear wheels is 0 +/- 1/2 degree. Piper recommends a carpenter's square for this purpose because of its especially long legs.

3. If the square contacts the rear side of the disc, leaving a gap between it and the front flange, the wheel is toed out. If a gap appears at the rear flange, the wheel is toed in.

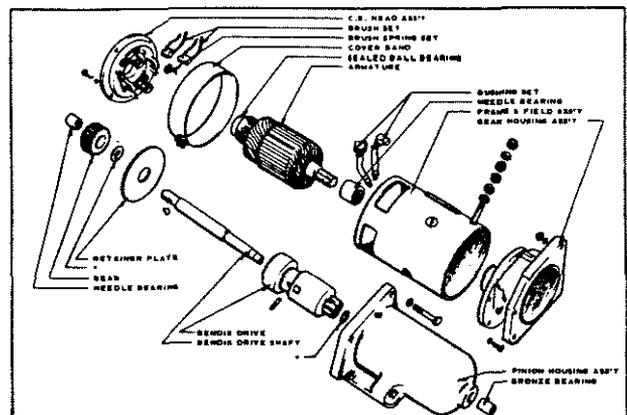
Exploded View of Gear Reduction Starting Motor

Unfortunately, this is not going to be easy - in fact, it is quite a chore. Plan on taking the entire motor and Bendix assembly out of the plane as a unit.

First, to avoid any possibility of a short, disconnect the battery ground cable. Then, undo all bolts and wires from the starter making notes as to where everything goes. Then remove the unit from the plane.

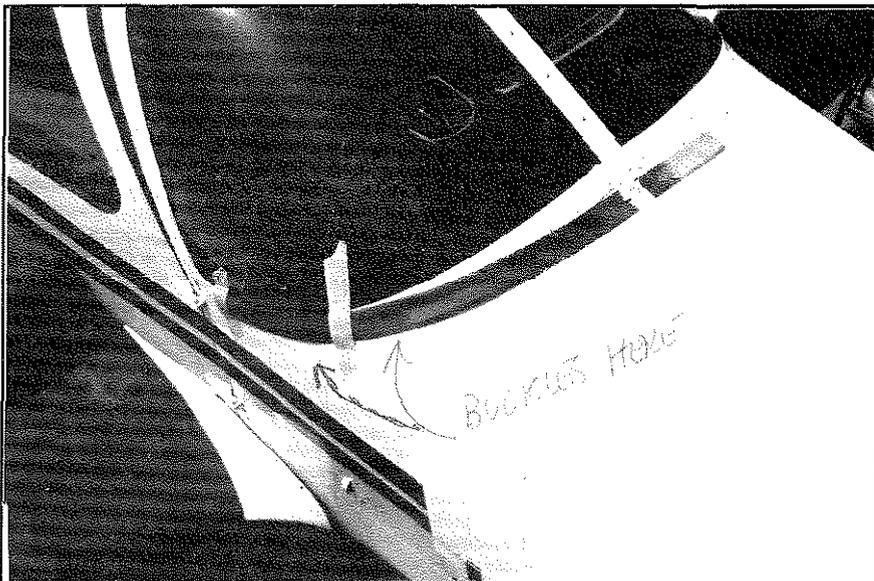
New Collar Buckled When Installed on Plane

severe buckle from a point about 13 inches from the trailing end, as seen in photo 2. In addition, the new part is nearly a half-inch wider than the original part. As a result, even if the part could be made to fit the turning radius, there is an ugly half-inch uneven union where the new part meets the

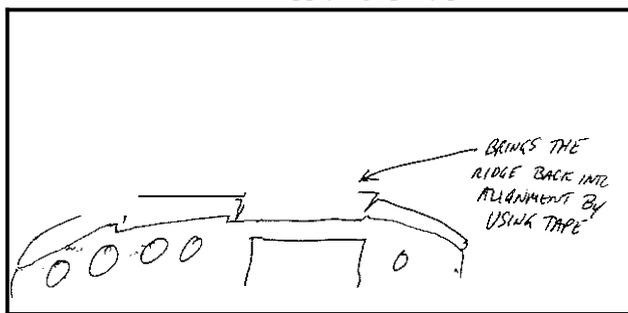
Next I applied a two-part epoxy paste to the backside of the panel where I found cracks and holes. Use a good quality tape on all cracks and holes. Tape the front of the panel and apply paste on the backside. The tape prevents the paste from protruding through the front and also helps to align the lip of the panel to nearly original alignment.

I had several large holes in the areas where screws hold the face to the aluminum panel. Previous owners had simply settled on using very large washers to hold and cover the enlarged holes. In many cases, the holes were so large I had to glue in small, dime-sized aluminum washers over the worn-out holes before applying epoxy paste to each hole.

After allowing to cure for a few days, I injected YB Weld into the front of the face in all cracks and areas where I attached aluminum washers, using a large veterinary hypodermic needle (I'm talking elephant grade!) Seriously, I'm not sure what size the needle was, I just went to my local ag-vet supply house and bought the biggest specimen I could find. The needle is a trick I learned from my experimental airplane building days. It allows you to apply glue to areas that are hard to reach or where you need precision in application.

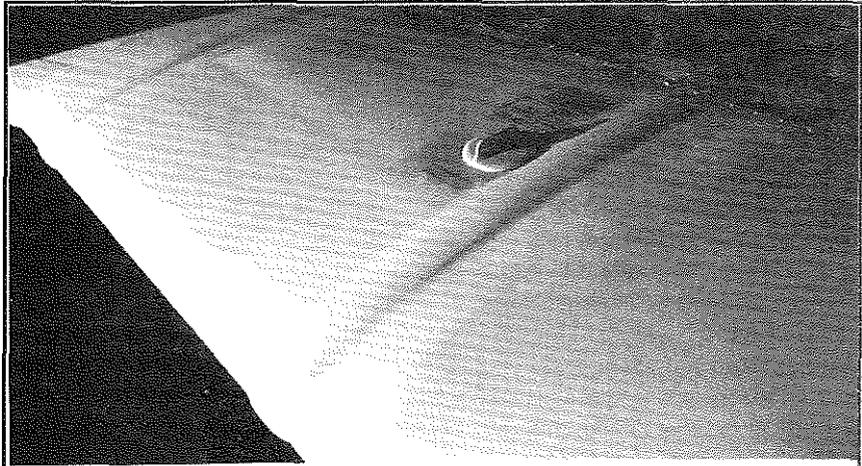
Fuel Tank Rivets are Covered by Fairing

The company offered a very comprehensive line of aerodynamic enhancements beyond aileron and gap seals, to include some attractive and very slippery looking wheel pants. I also liked their flap hinge fairings and fairings that cover the screws, seams and rivets along the fuel tanks. Talk about a dirty airfoil - Cherokee wing tank screws and rivets resemble something one would expect to see holding iron blanks together on a WWII battleship.

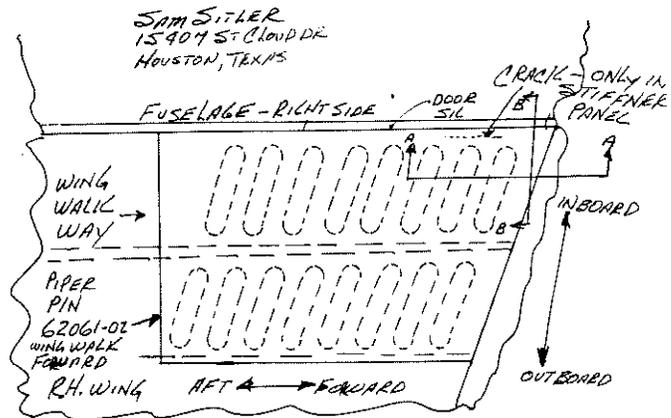
Skin Cracks in Warrior Wing

and stiffener can be replaced by using blind cherry rivets in the inboard rib. The remainder of the rivets are accessible through the inspection openings. This repair, by replacing the panel, does not solve the basic design problem which

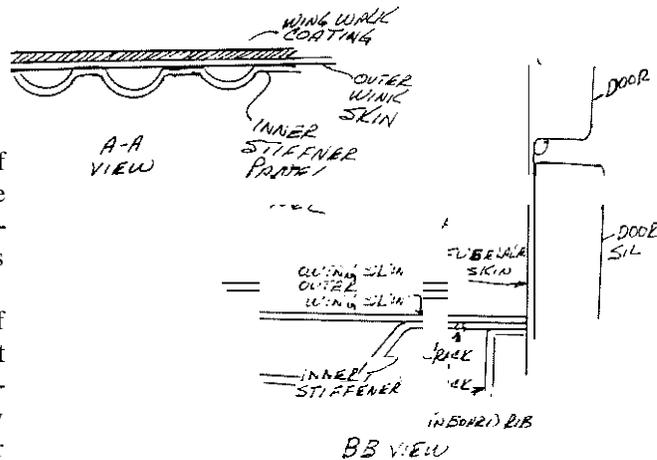
allows the cracks to develop in the first place. This appears to be a design problem which is created by causing a concentrated load to be applied on the wing skin directly where the foot is placed when entering or exiting the cabin.

I have developed several fixes but have not received approvals as of now. One fix would be to add channels in between the raised portions of the stiffener. With clips on each end of the channels, these would transier the vertical load (someone standing on the wing walk) into the webs of the inboard rib and first outer rib.

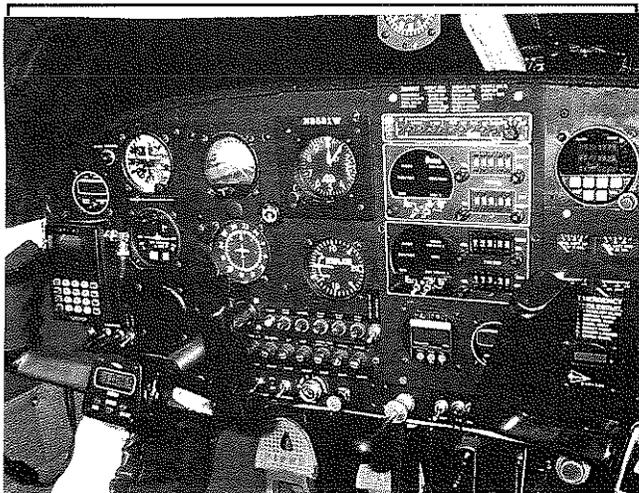
Panel Has Military Look-Note Lack of Plastic

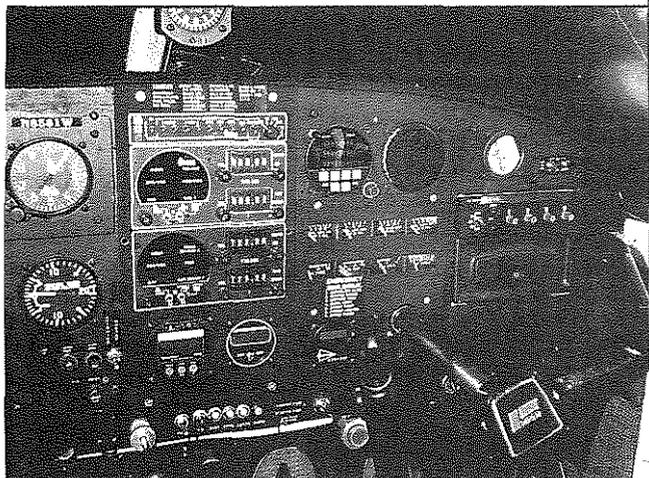
View of Right Hand Side of Redone Panel

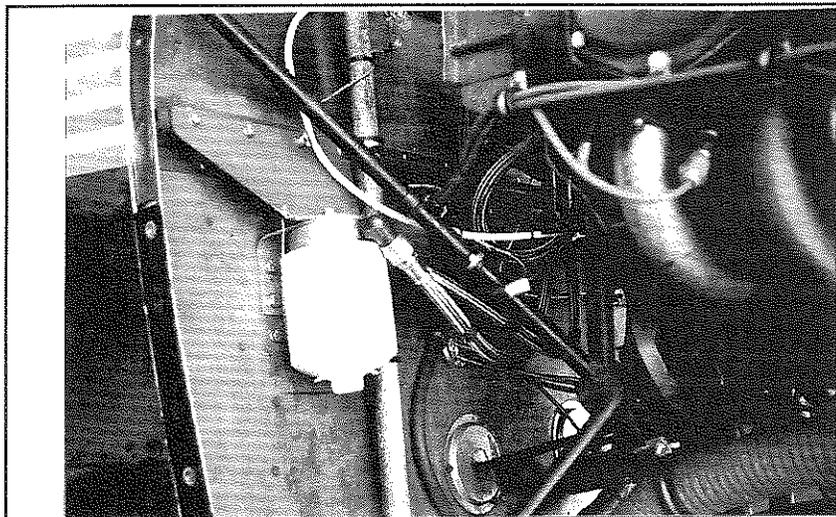
This is really a piece-of-cake installation except for one hitch: there is usually not a really sturdy place on the firewall and a doubler or reinforcement plate is almost always needed. I used a triangulation scheme where I mounted a plate from the top of the filter bracket to the cross-brace on the firewall.

Airwolf Remote Filter Makes Neat Installation; Easy Oil Changes

This not only stiffens the flexure of the firewall, but also limits the rotational pivoting of the bracket itself.

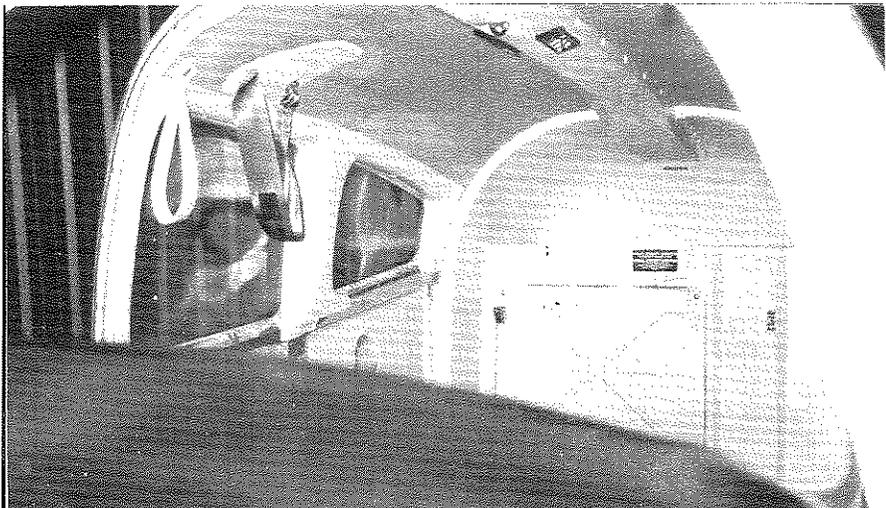
New headliner, side windows & refurbished plastic trim

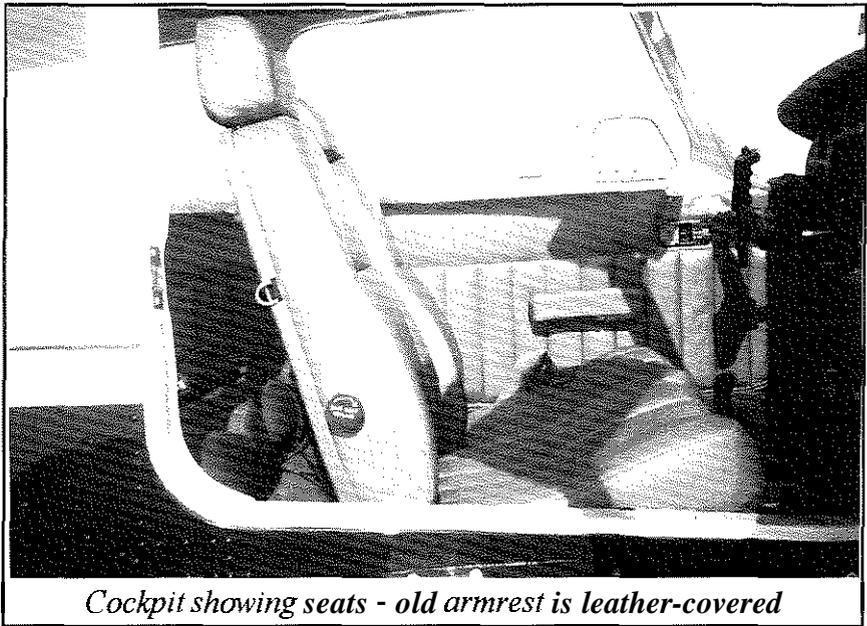
Cockpit showing seats - old armrest is leather-covered

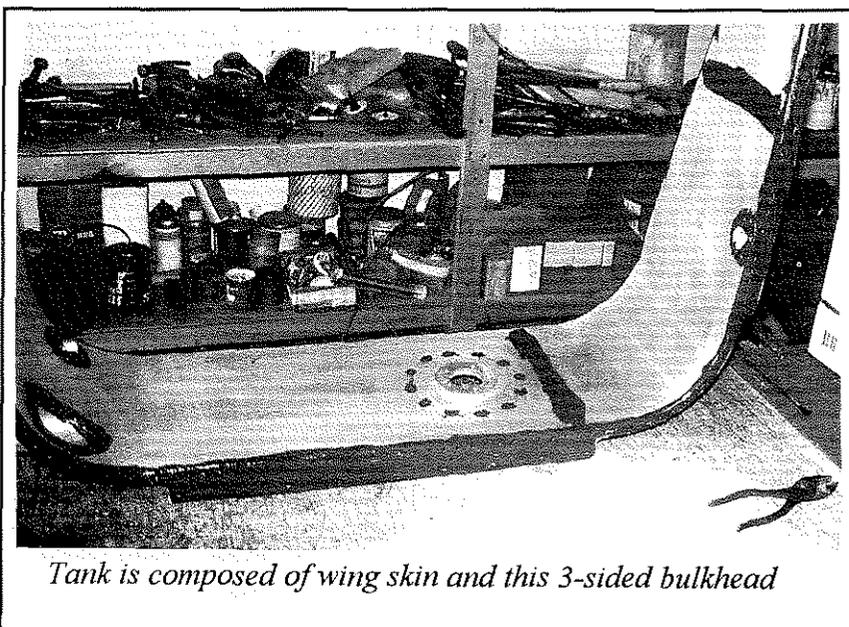
Notation is made of the date received and any discrepancies noted. The tank is made of a skin of the wing and a three sided bulkhead which is riveted to the skin with 250 soft rivets. This creates the tank which holds the fuel. The Lance and Seneca tanks also have an internal rib for additional strength.

Tank is composed of wing skin and this 3-sided bulkhead

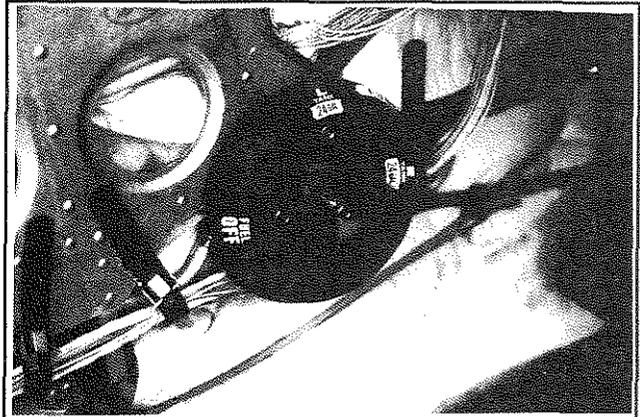
Position the selector knob to the off position before removal. There will be a half-round index on the selector shaft that allows the knob to be installed in only one position.

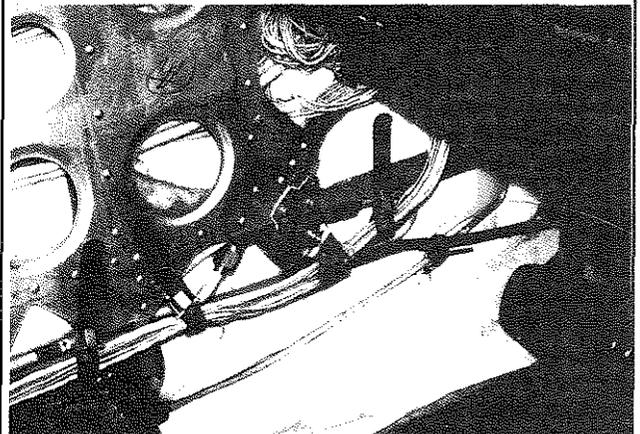
With the cover off, the valve can be seen attached to the fuselage structure. Be sure to drain all the fuel from both tanks before loosening the fuel lines.

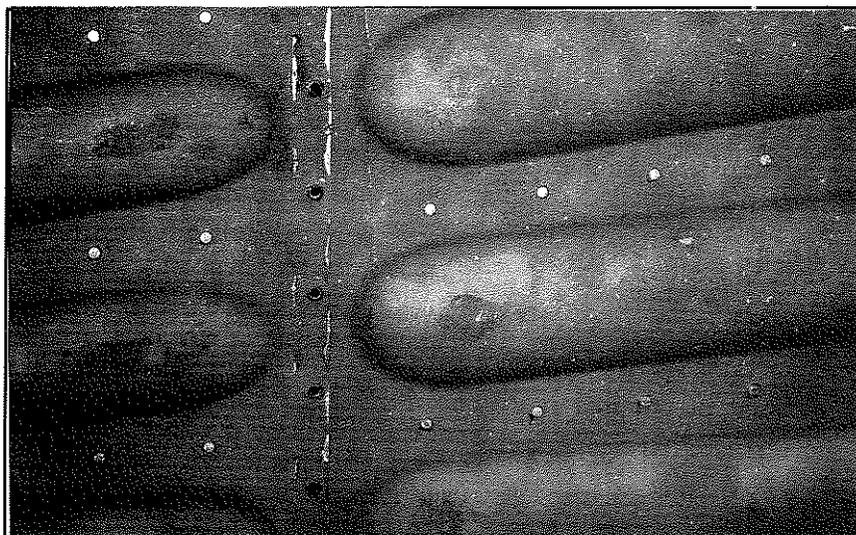
The close up photos clearly show a complete absence of corrosion on any areas of the spar cap, spar web, or ribs; nevertheless, we also complied with that element of the service bulletin which requires Dinotrol Av-8 to the in-

Closeup reveals cracks in wingwalk skin doubler, Every older Cherokee aircraft has potential for this problem.
